## HAMER ESTATE – COMPLETED WORKS APRIL 2011

Environmental improvements to Hamer estate were carried out during February and March 2011. Below are photographs showing before and after of various elements of the environmental programme.

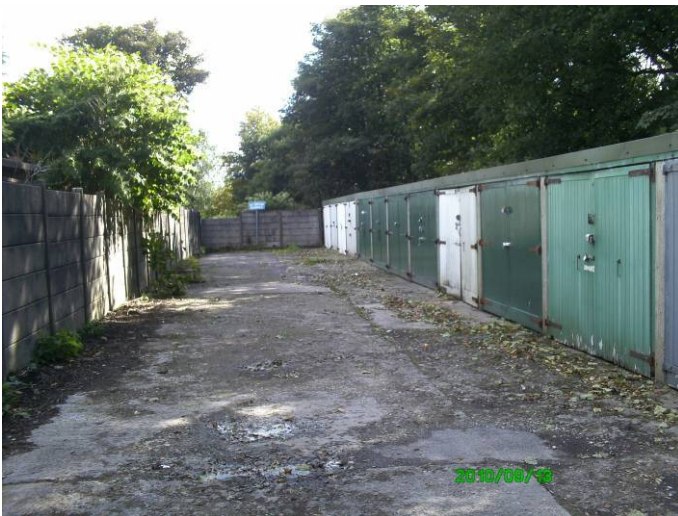
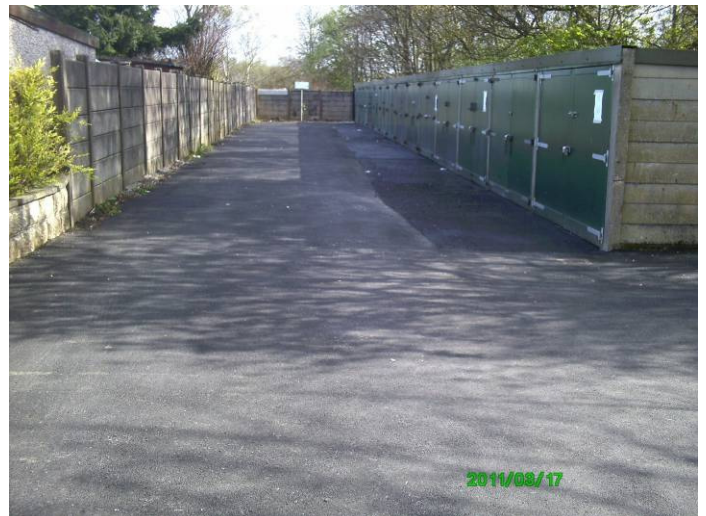
### Foxholes Garage Site

The surface to the garages was in very poor condition and breaking up. The broken up surface has been removed and re-surfaced with tarmac. Some missing fence panels between the garage site and the open space at the top end of the site have also been replaced to make the area more secure.

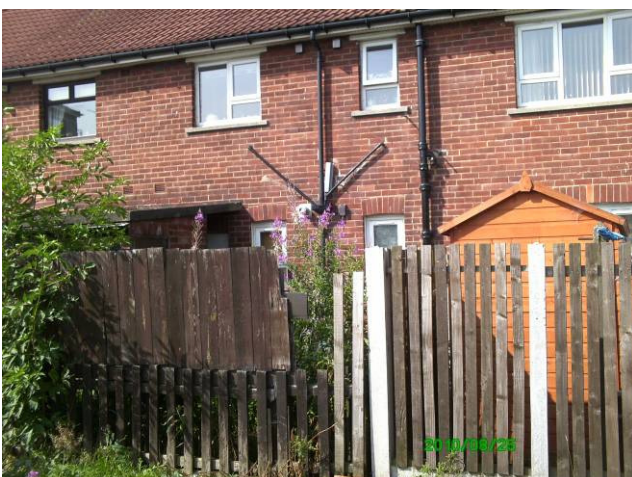
Before

The rear fencing backing onto an alleyway was in poor condition, with some of the fencing only being 1.0 metre high. This has been replaced with 1.8 metre high timber to provide privacy and security.

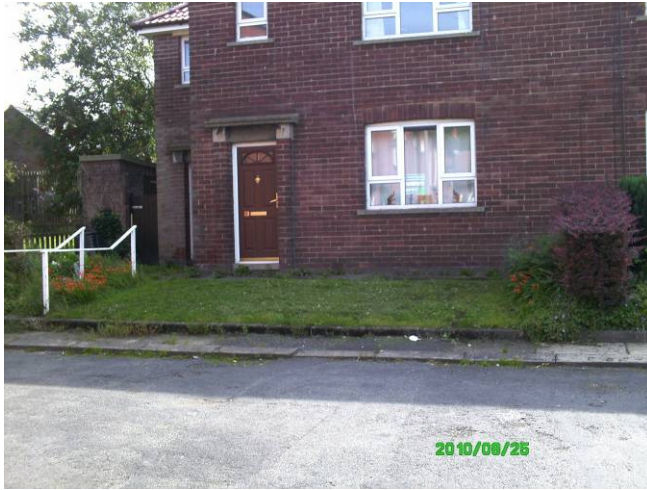
Before

The front garden area was open to the footpath, a new front fence has been installed to provide a defensible space/private garden area for the tenants of these flats.

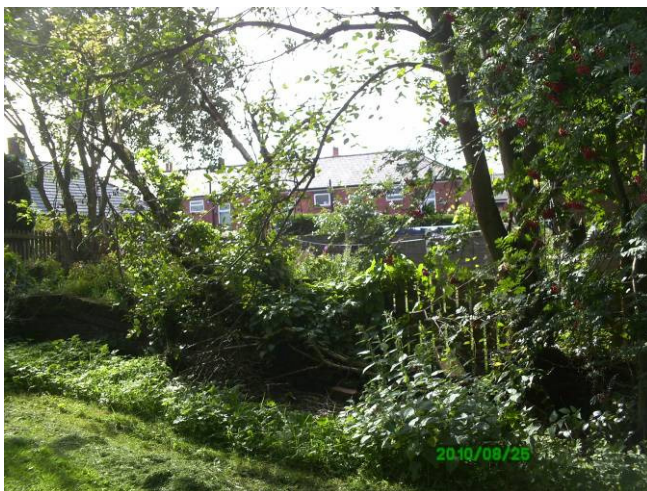
Before

The side garden is adjacent an open piece of land which is used as a short-cut. The existing fence was low and in poor condition with overgrown shrubs and trees. The bushes have been cut back leaving the mature and healthy trees and a new 1.8 metre high fence has been installed along the rear/side boundary of these flats.

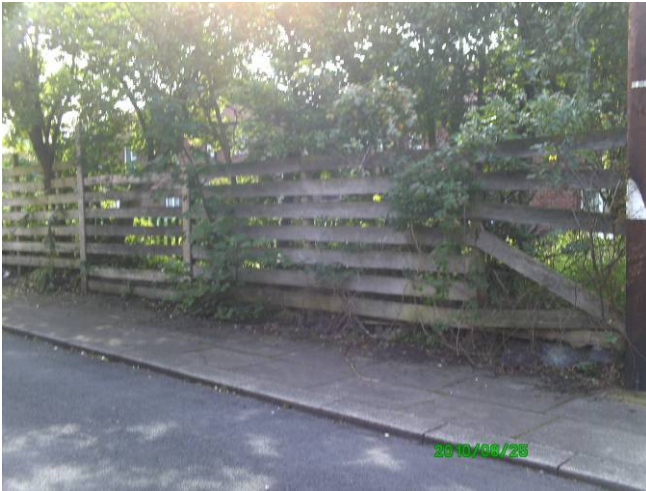
Before

The fencing to the rear of Alice Street flats was in very poor condition and adjacent a highway. This has been replaced with a 1.8 metre timber fence which not only provides more security for the rear gardens but improves the visual aspect of the adjacent street.

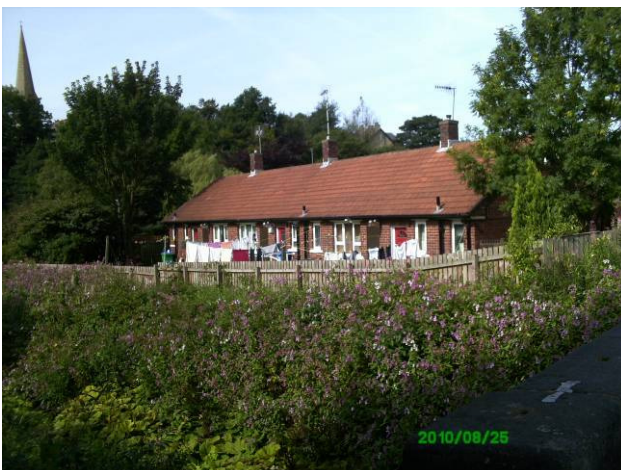
Before

The rear of these bungalows is adjacent the river bank and the fencing had horizontal rails on the outside which made it easy for anyone to climb over. The fencing was externally boarded to cover the horizontal rails and prevent people climbing over.

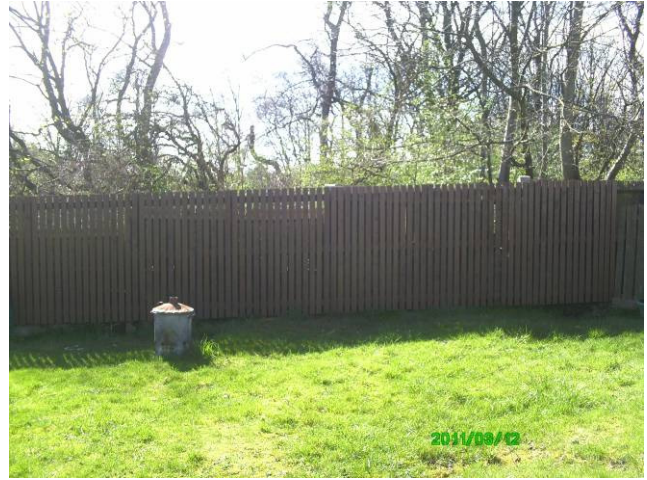
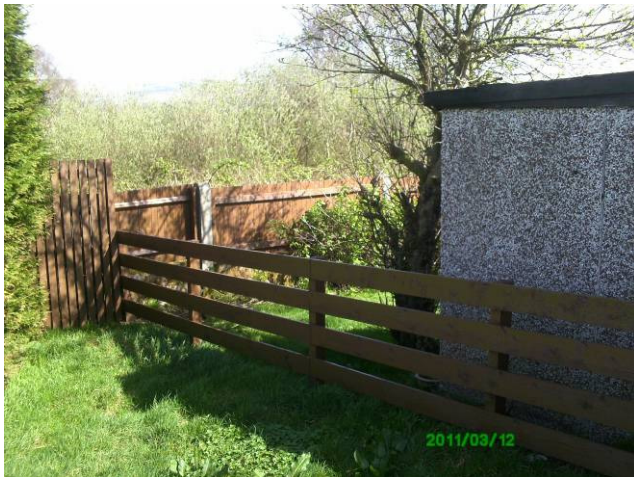
## Foxholes Close bungalows

These bungalows back onto open land and there have been instances of anti-social behaviour. The existing fence was low and easy to climb over. This has been replaced with a new fence which is 1.8 metres high to prevent people accessing the tenants gardens from the adjacent open space.
